## PROPERTY INSPECTION REPORT

**Concerning:** 1234 Main Street, Austin, TX  
(Address or Other Identification of Inspected Property)

**By:** Sam B. Guynes Prof. Insp #5486 9/12/06  
(Name and License Number of Inspector) (Date)

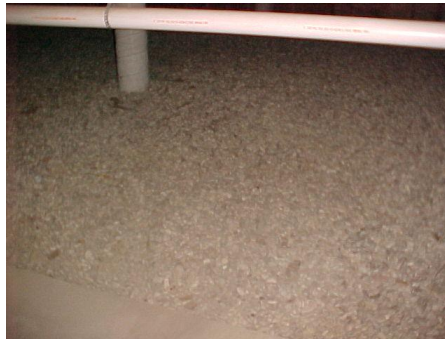
Minor earth to wood contacts and near earth to wood contacts at various areas along foundation perimeters; boards in question appear to be pressure-treated wood.

No perimeter solid concrete foundations in place-concrete piers.

A moisture barrier should be installed on the crawl space floor.

Minor earth to wood contacts and near earth to wood contacts at various areas along foundation perimeters; boards in question appear to be pressure-treated wood.

No perimeter solid concrete foundations in place-concrete piers.

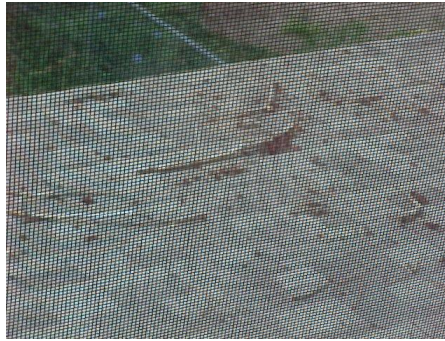
Debris should be removed from the roofing in various locations, e.g. front.

Debris should be removed from the roofing in various locations - e.g. front.

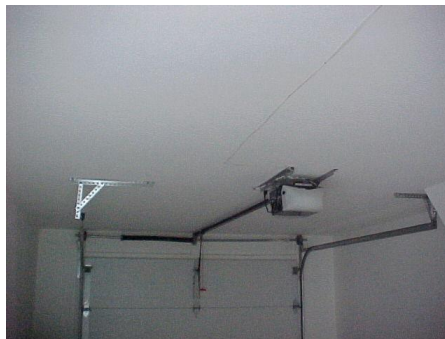
No attic access hatches at detached garages (very small attic areas).

No attic access hatches at detached garages (very small attic areas).

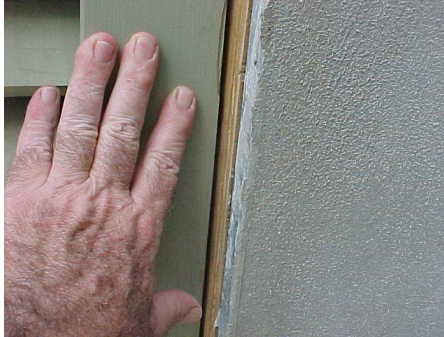
**No proper door stops at sub area entry doors.**

No proper door stops at sub area entry doors.

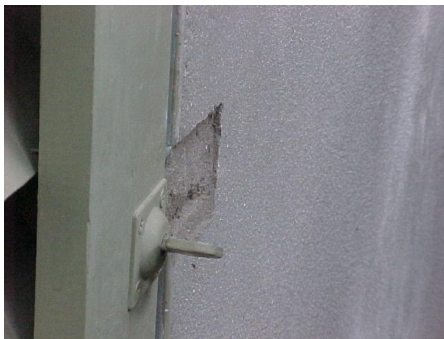
**No hasp in place at north side garage sub area entry door.**

No hasp in place at north side garage sub area entry door.

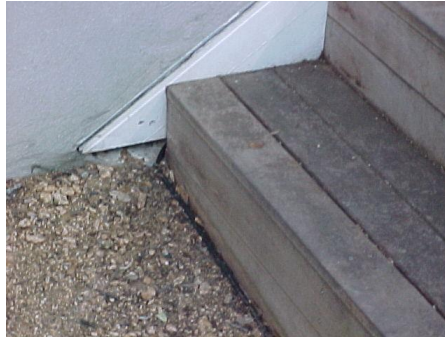
Minor earth to wood contacts at various areas of porch and step areas (wood members appear to be pressure treated wood);

Minor earth to wood contacts at various areas of porch and step areas (wood members appear to be pressure treated wood); no steps off rear porch for easier access/safety.

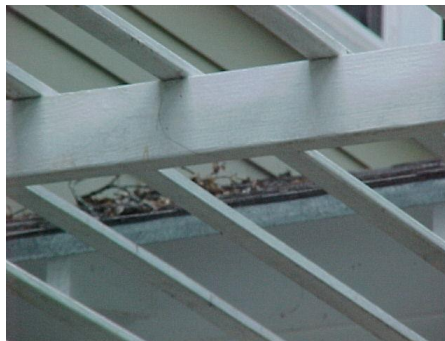
**Overhead trellis wood members in rear appear due for preparation/primer/paint/caulk.**

Overhead trellis wood members in rear appear due for preparation/primer/paint/caulk.

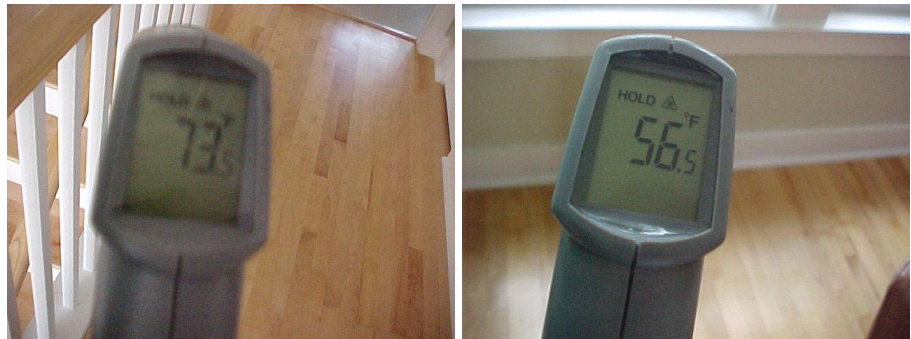
FYI - cooling differential (both units) (temp F at warm air return less temp F at cool air supply) measured within acceptable range.

FYI - cooling differential (both units) (temp F at warm air return less temp F at cool air supply) measured within acceptable range.

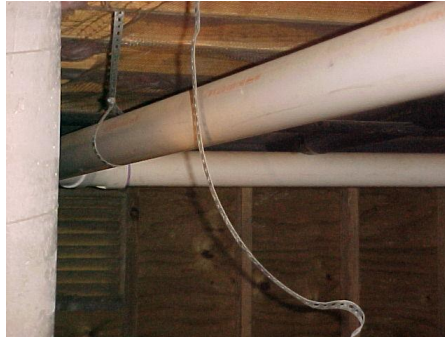
**Broken metal retaining strap at PVC drain line in sub area.**

Broken metal retaining strap at PVC drain line in sub area.

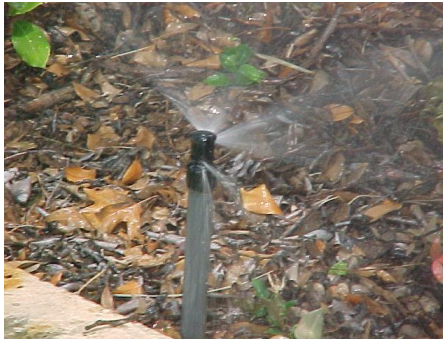
e.g.- station #3-north side shrubs.

Lawn Sprinklers: OBSERVATIONS: Very minor seasonal head adjustments due at various sprinkler heads- e.g.- station #3-north side shrubs.
